Manhole Inspection Summary

Manhole # S49M__003MH

Insp Date: **4/16/08 9:34 AM**

Location Address: **rear 2511 fait ave**

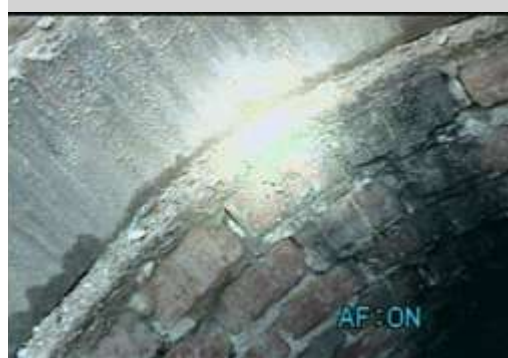
Defect 3

bench debris

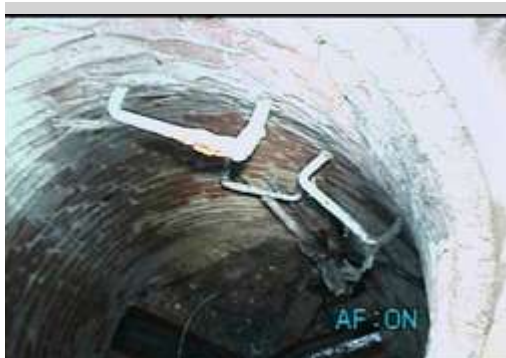
Defect 1

Condition: ☐ Sound ☐ Cracked ☐ Root Intrusion ☒ **Loose Brick** ☐ Deteriorated

Infiltration: ☐ None ☒ **Joint** ☐ Cracks ☐ Mortar ☐ Roots ☐ Wall

corbel loose bricks and infiltration, offset
